# Appendix E - Burn Brae Maintenance Review

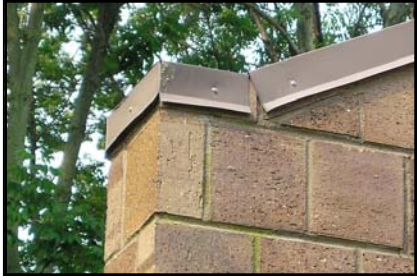
<p>Incomplete flashing allows water penetration</p>

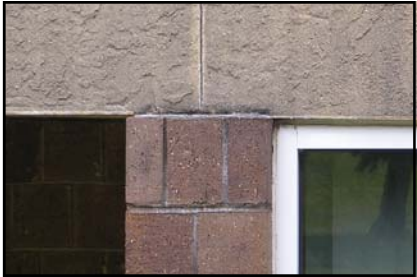
<p>Bad detail of brick extending beyond face of stucco allows water penetration</p>

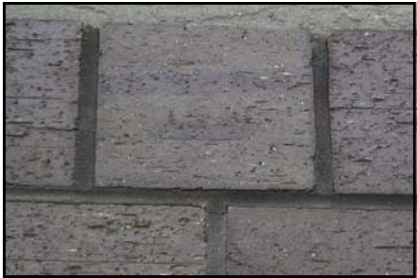
<p>Water penetration provides freeze-thaw pressures that result in mortar joint cracks around the Building</p>

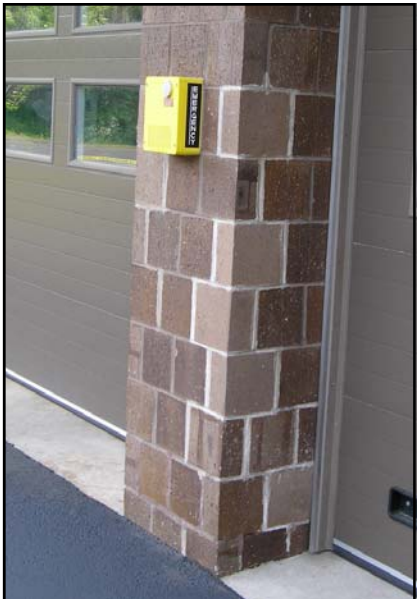
<p>Lack of protective bollard resulted damage that was repaired without adequate attempt to match brick &amp; mortar colors</p>

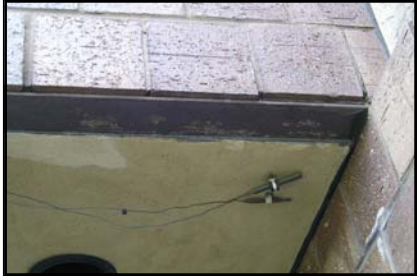
<p>Water leakage from improper flashing &amp; poor brick detail (brick extends beyond stucco above) results in soffit failure</p>

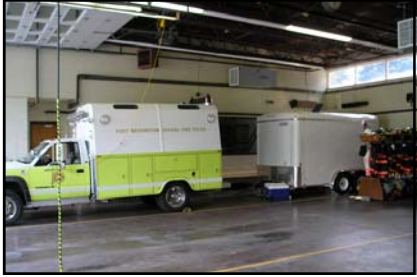
<p>Epoxy floor with specific coefficient of traction should be installed as a safety measure</p>
